Preferred Direction of Damage to Concrete Block Fences in the M6.7 Northridge Earthquake of 17 January 1994

David L. Snyder^{a)} and Glenn Borchardt,^{b)} M.EERI

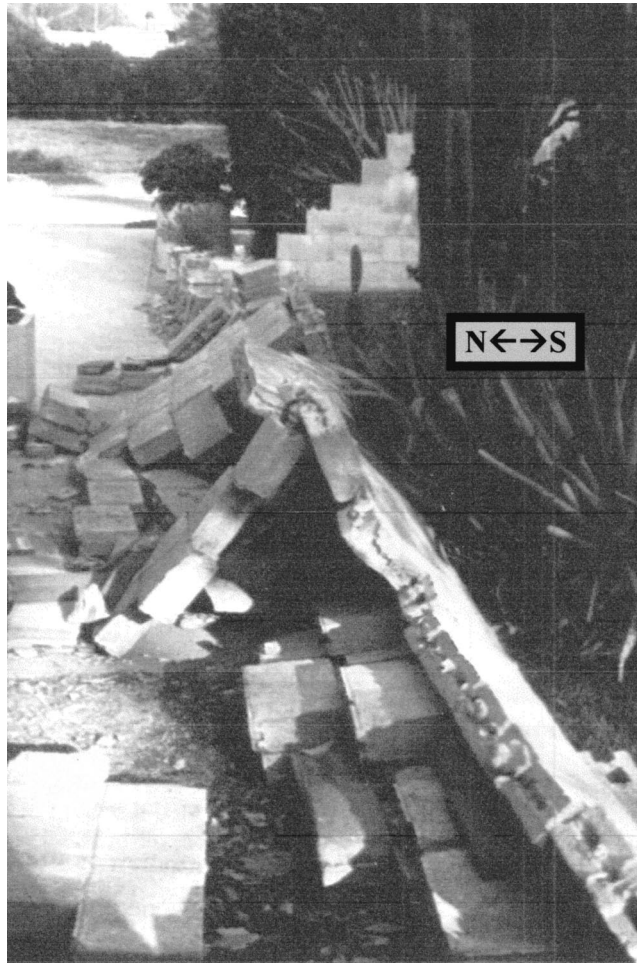
Figure 2. Typical concrete block fences used to demarcate property lines in the San Fernando Valley. An E-W oriented fence is in the foreground and a N-S oriented fence is in the background.

With these concrete block fences, complete toppling results from total failure or overturning at the foundation level. Complete toppling only occurs with movement of the fence as a solitary unit. The toppled fences seldom showed any evidence that they had experienced more than a quarter-cycle of motion (Figure 2). Thus we suspect, in the light of Paret and Borchardt (1995) and Paret et al. (1998), that many of these fences toppled in response to motion that was parallel to the direction of rupture propagation. The effect was particularly dramatic in the NW quadrant, immediately above the aftershock zone. Here, only fences oriented E-W were toppled; none were oriented N-S. It appears that fences that escaped the initial motion without toppling were then subjected to cyclic motion that produced numerous shear cracks and other types of damage apparently unrelated to direction.

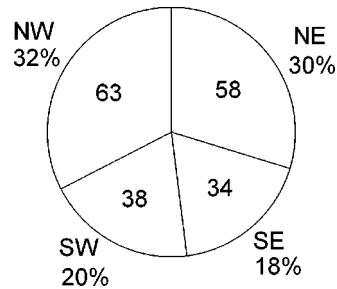
Earthquakes normally have the most intense shaking in the direction of fault rupture, a process called “forward rupture directivity” and documented with strong motion records for Northridge by Somerville and Smith (1996) and Somerville et al. (1996). At first glance, Figure 3 would appear to be evidence for this: 62% of the failed fences in our data set were north of the latitude of the epicenter, in the direction of rupture. However, the low density development and the dominantly bedrock sites in the Santa Monica Mountains also could be responsible for the lesser number of failed fences south of the epicenter. There were only a few failed fences over 10 km north of the epicenter, although the developed area in the San Fernando Valley extended to stiff soil and bedrock sites over 15 km to the north.

Figure 3. Numbers of failed fences by quadrant.

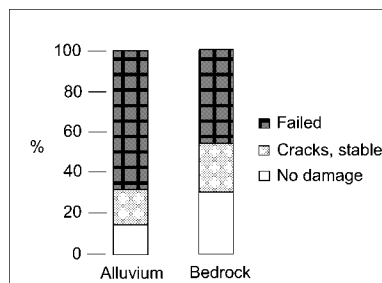
Fences built on alluvium had a greater tendency to fail than those built on bedrock (Figure 4). Although 14% of the fences were on bedrock, only 9% of the failed fences and only 3% of the toppled fences were on bedrock. (The one toppled fence on bedrock

actually was founded on 5 m of fill; a parallel fence built entirely on bedrock did not fail.) Most fences lacked adequate foundations, so foundation type could not have been a significant factor in preventing damage on bedrock as opposed to alluvium.

Figure 4. Fences on alluvium had a greater tendency to fail than those on bedrock.

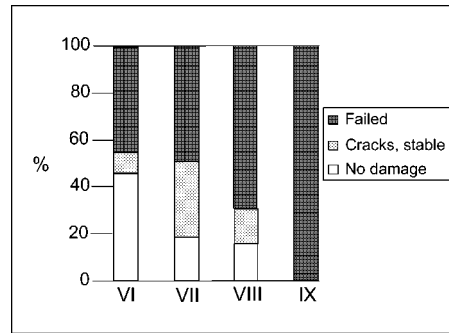
At least a few fences in each damage category were found in all MMI zones assigned by the site evaluators (VI to IX), so fence failure was not the sole criteria for the MMI designation. Nevertheless, the tendency to fail was directly related to the assigned MMI (Figure 5). Fence reinforcement dropped the failure rate from 79% to 27%. Only one reinforced fence toppled completely.

Figure 5. Fence damage in relation to Modified Mercalli Intensity.
